## What is the correct ring size for female African Black Oystercatchers Haematopus moquini?

## Bo Bonnevie<sup>1</sup> & Sophie Kohler<sup>2</sup>

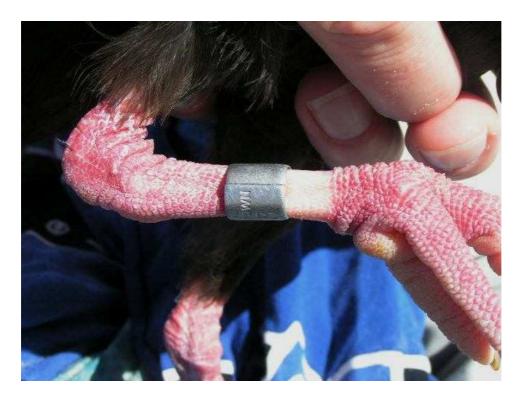
We have re-trapped females with constricted tarsi clearly caused by rings that are too small (Fig. 1). The damaged tarsus is thinner than that of the other leg and discoloured because of reduced blood circulation (the colour of the tarsus under a loosely fitted ring is much darker). An additional problem is that when rings are fitted they are often closed into a round shape. The tarsi of African Black Oystercatchers are not round, so the rings should be flattened to fit the leg properly. This will also provide a looser fit for the same ring size. We flattened the ring on the female tarsus shown (Fig. 1) after which it could move up the leg, although it was still a tight fit.

**Fig. 1.** Tarsus of a female oystercatcher damaged by a constricting ring (photo: Sophie Kohler)

SAFRING does not supply 9mm SS rings at present. We, therefore, started using 10mm SS rings on females as this is the next largest size available from SAFRING after the 8mm ring. Many African Black Oystercatchers are, however, ringed as chicks which cannot be sexed in the field. We, therefore, recommend that a 9mm SS ring should be sourced and used for both sexes of the African Black Oystercatcher in the Eastern Cape.

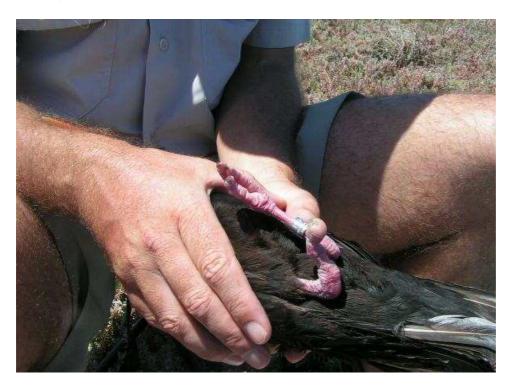
During this field work we have seen quite a number of oystercatchers with one foot missing and one was also caught (Fig. 2). It is possible that tightly fitted rings could cause this sort of injury. We have also caught birds with fishing line tangled around their feet and this also could possibly cause such injuries. It would be interesting to survey missing feet on oystercatchers: if there are more injuries on the right foot (where the ring is typically fitted) this could be an indication that too small a ring size contributes to these kinds of injuries.

**Fig. 2.** Dr Paul Martin holding an oystercatcher with a missing right foot (photo: Sophie Kohler)
